Hydrodynamics survey along embankments of Kumirmari Island Gosaba, Indian Sundarban

INTRODUCTION

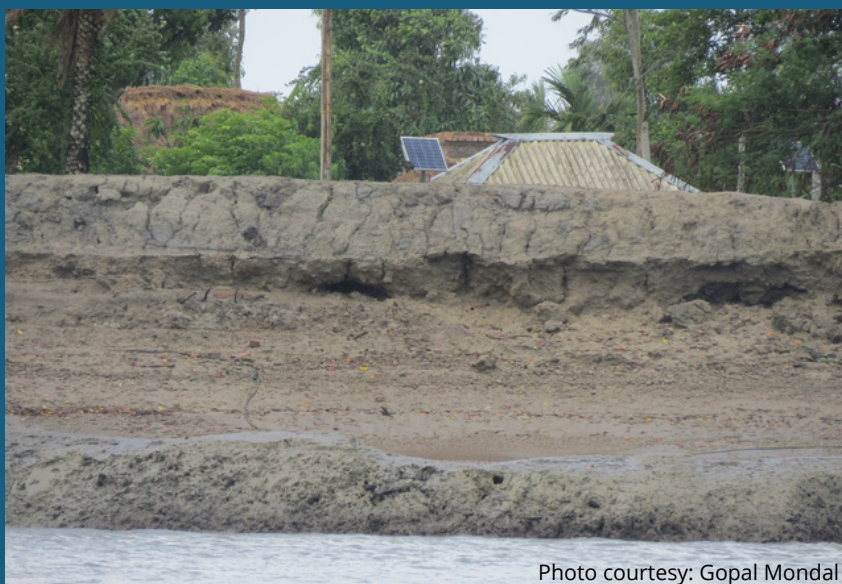
Eroding embankment in Kumirmari with visible signs of undercutting. The embankment is the only defense between the saline water and the homestead and cultivable lands of the residents.

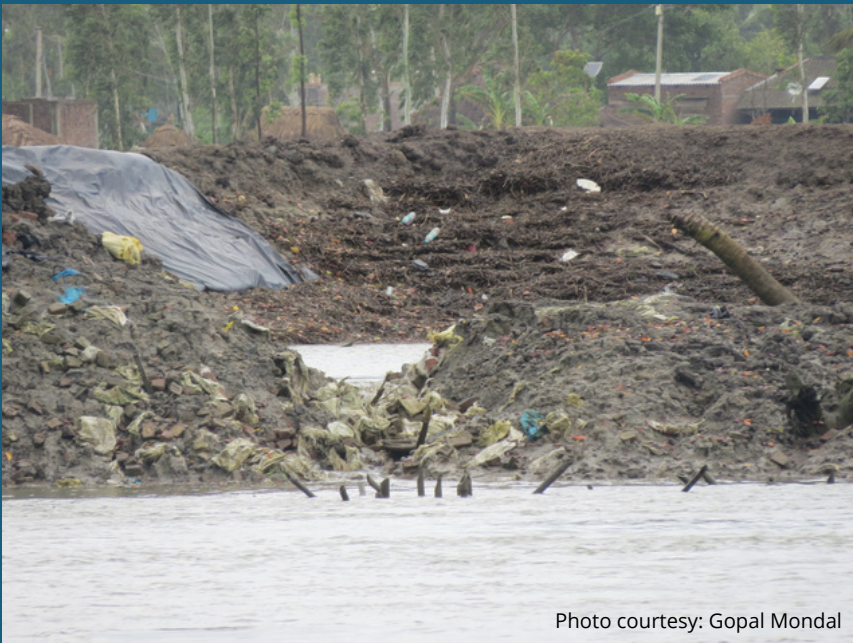
A breached embankment along southern Kumirmari. The breach in the older embankment caused during Cyclone Yaas is visible in the foreground and the new embankment constructed further inland is visible in the background.

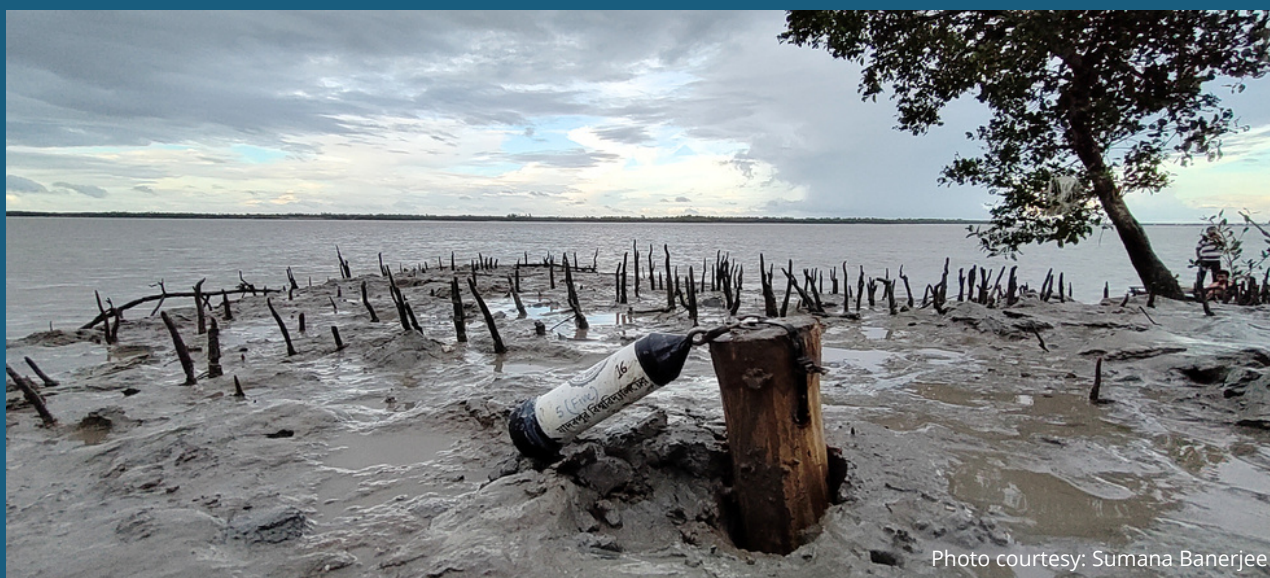
The Mini Buoy comprises an acceleration data logger placed inside a small, bottom-mounted float. The data logger measures acceleration along three axes relative to the Earth's surface and is used to determine the inclination and direction of motion. When properly calibrated, the dip angle of the Mini Buoy can determine:

- **start and end time of submersion periods;**
- **current velocity near the bed;**
- **wave orbital velocity near the bed**

Mini Buoy in the mudflat of Indian Sundarban to characterise the hydrodynamics

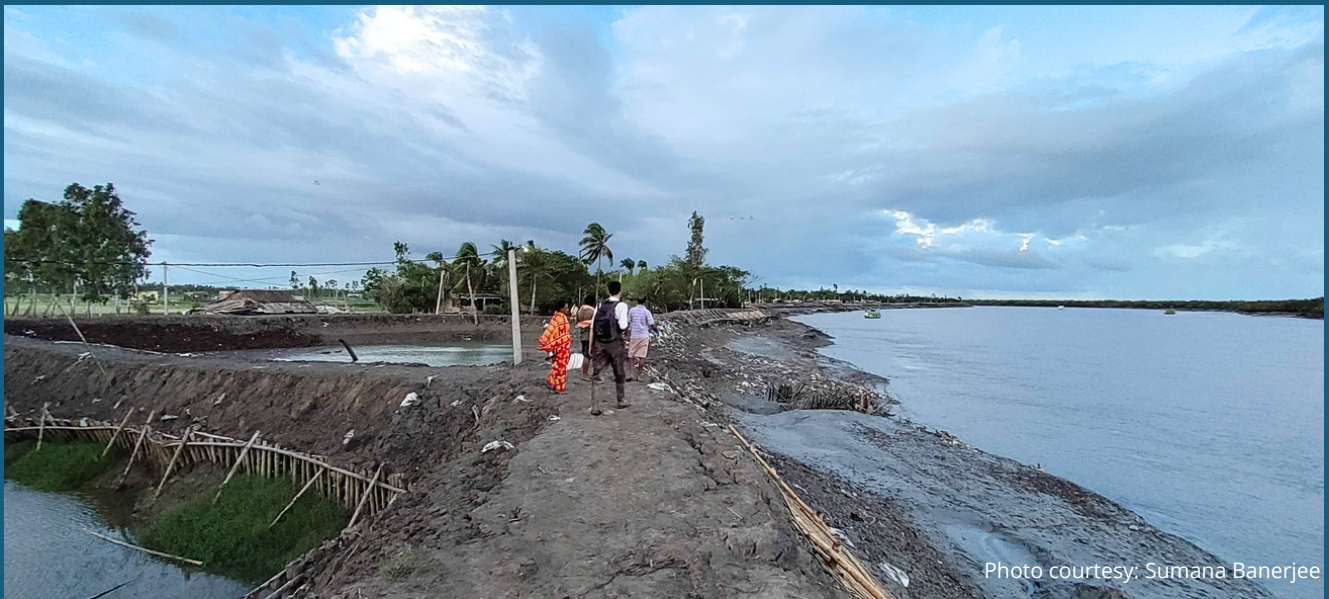
Concerningly, mud embankments experienced greater exposure to currents and waves than concrete embankments, even though the period of inundation was comparable. **The south-western peak of Kumirmari, where only mud embankments with unvegetated foreshores are found, had the greatest level of exposure.** Increased exposure to wave and current forcing is expected here, as water depths in front of the coastline were, on average, 6.7 m greater than the western side, allowing larger waves and currents to reach the eroding coast. Southern Kumirmari has suffered the highest rates of coastal erosion compared to anywhere else on the island over the last decade and so warrants special attention when developing coastal flood risk mitigation strategies.

Newly constructed mud embankment along south-western peak of Kumirmari after it breached in multiple sites during Cyclone Yaas (2021).

Only mud embankments with unvegetated foreshores are found here which had the greatest level of exposure. The land of the foreshore and the newly constructed embankment now exist at the spot where once stood homestead land and property of residents. Destruction of property bears the tangible mark of erosion and the countless human lives bear the intangible marks where erosion affects their identities, memories, and wellbeing.

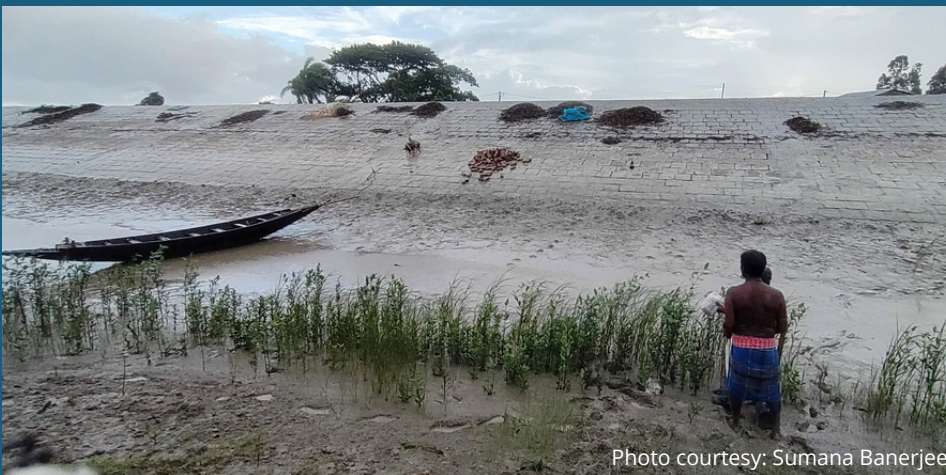
Sparse vegetation in front of a newly constructed concrete embankment

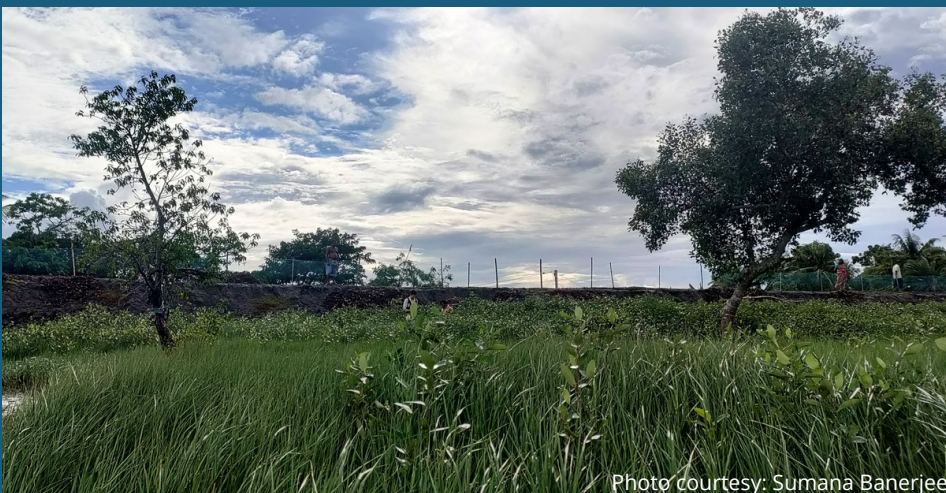
Young mangrove and saltmarsh plantation with two mature mangroves in front of mud embankment

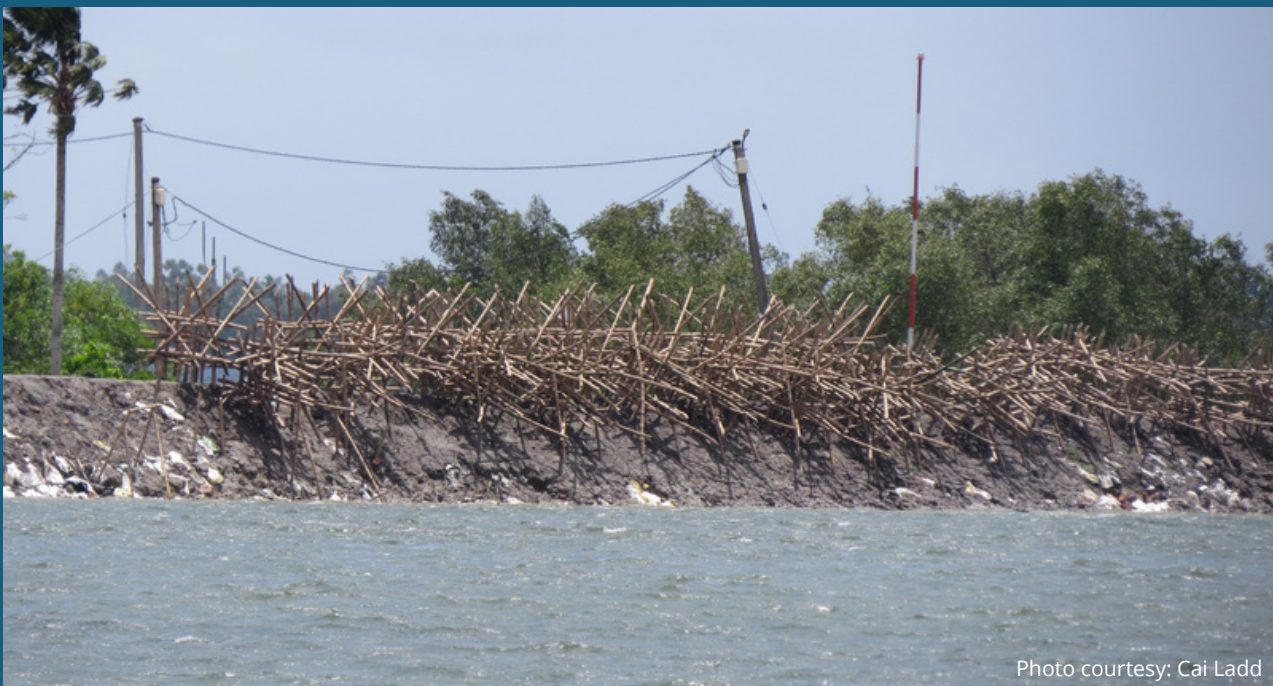
Porcupine System used to trap sediments and prevent erosion in Indian Sundarban

Other novel approaches - Growing intertidal areas include the use of sediment arrestors and wave breaks deployed along coastal fringes. Effective use of such techniques requires understanding the underlying cause of erosion (e.g., insufficient sediment supply to keep pace with sea level rise, excessive current flow by migrating channels, and propagation of large waves along river channels).
